ESECMaSE

Enhanced Safety and Efficient Construction of Masonry Structures in Europe

**D 7.1a Test results on the behaviour of masonry under static
(monotonic and cyclic) in plane lateral loads**

University of Kassel
Institute of Structural Engineering
Chair of Structural Concrete
Kurt-Wolters-Straße 3
34109 Kassel

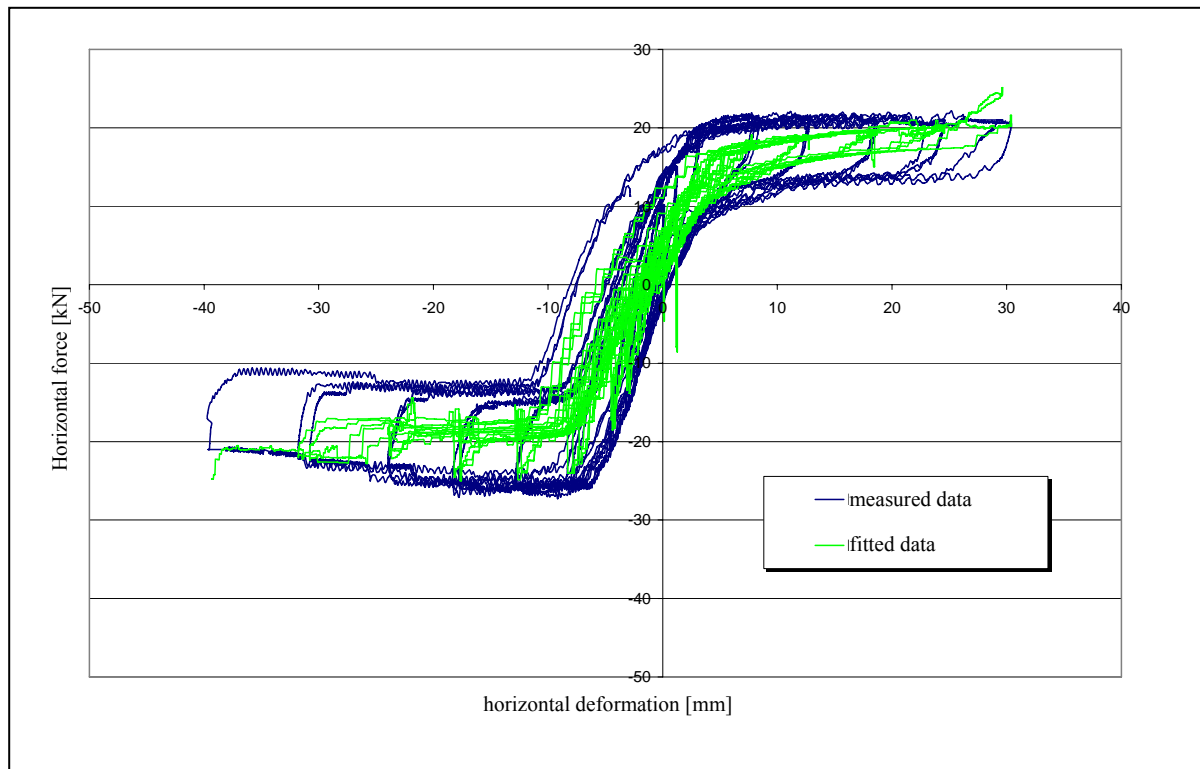
Thus an adjusted hysteresis curve of the masonry wall can be determined, in which all energy dissipation rates caused by the test-setup are eliminated. Figure 4 shows the hysteresis of specimen No. 14 as measured hysteresis and as adjusted hysteresis curve (with compensation of parasitic energy dissipation), respectively. Herewith it can be shown that the adjusted hysteresis curve is not shaped as “bellied” as the measured hysteresis, i. e. a minor part of energy is dissipated compared to the measured, unadjusted values. The load bearing capacity values as determined from both curves differ just marginally.

For defining the adjusted hysteresis curve, both the vertical deformations of the horizontal cylinder and the horizontal deformation of the testing frame must be measured. However, this had been done for test specimen No. 14 only. In the following the other test results are displayed as measured hysteresis for this reason. At this it should be noted that the damping of the masonry wall and the energy dissipation, respectively, are over-estimated by the measured raw-data.

figure 4: Comparison between the adjusted and the measured hysteresis

The peaks of revised curve result from numerical problems. Smoothing functions can calendar this peaks, but this leads to a deformation of the hysteresis curve.

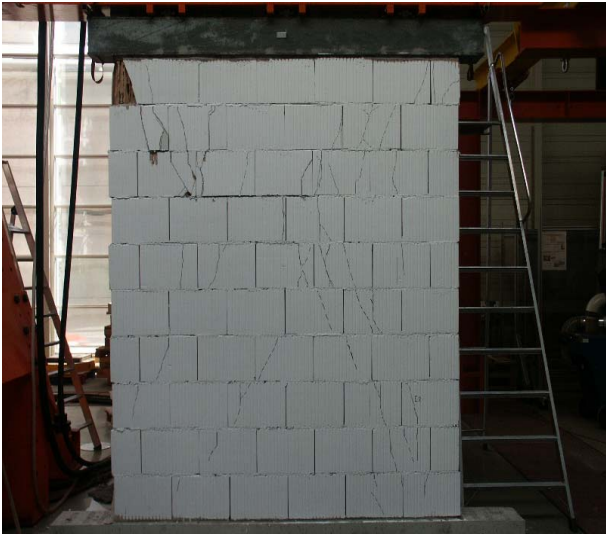
At a horizontal force of about +48 kN cracking was audible. The first visible cracks appeared at a horizontal force of about -102 kN in the bottom right corner (see figure A3-1). The end of the test is determined by the failure of the upper left corner of the wall (see figure A3-2).

figure A3-2: crack pattern of test No. 3

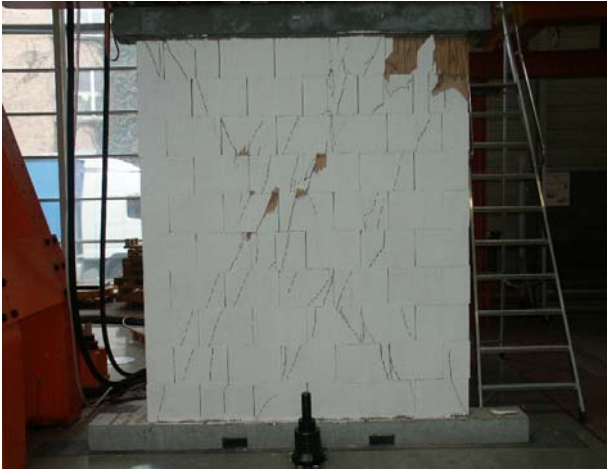
Within the vertical loading at a vertical force of -360 kN a cracking is audible. At a horizontal force of about +87 kN cracking became audible again. From a horizontal force of about +110 kN the cracking becomes louder. The first visible cracks appeared at a horizontal force of about -130 kN in the left upper corner (see figure A4-1). The end of the test is determined by the failure of the upper right corner of the wall (see figure A4-2).

figure A4-2: crack pattern of test No. 4

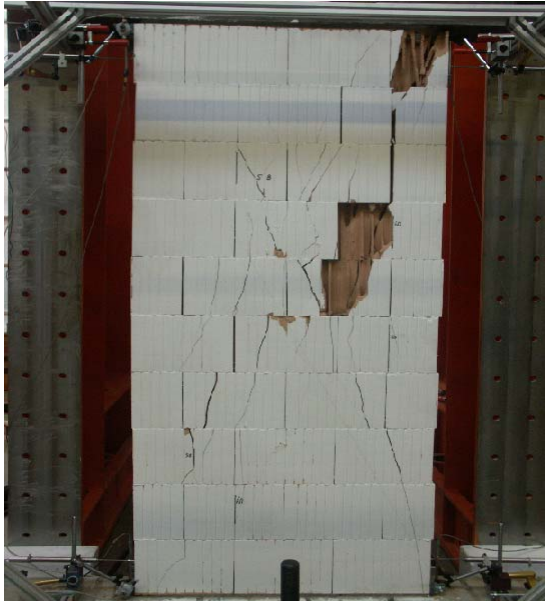
The first visible vertical crack appeared at a horizontal force of about +50 kN (see figure A7-1). The first visible cracks in the diagonal direction appeared at a horizontal force of about +58 kN in the middle of the wall. The end of the test is determined by cracks in the middle and in the right upper corner of the wall, where shells of the vertically perforated bricks fell down (see figure A7-2).

figure A7-1: first cracks at about 50 kN of test No. 7

figure A7-2: crack pattern of test No. 7

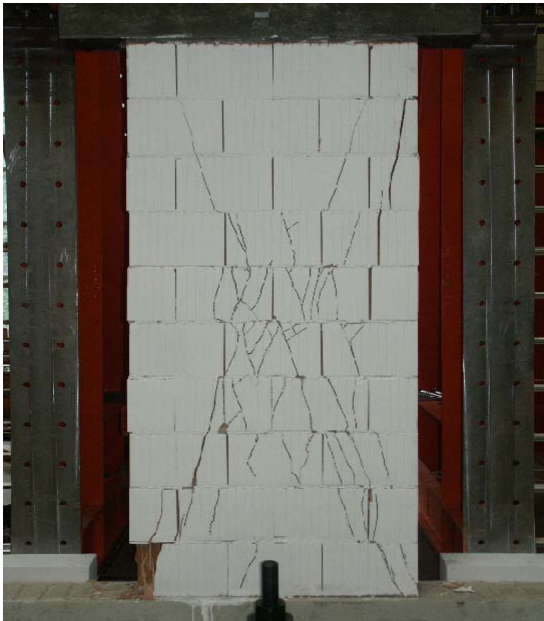
At a horizontal force of about -63 kN a first cracking was audible and cracks appeared at in the bed joints of the wall (see figure A8-1). A sliding in the bed joints was visible (see figure A9-2). The end of the test is determined by cracks in the bottom right corner of the wall at a horizontal force of -66 kN.

figure A8-1: crack pattern of test No. 8

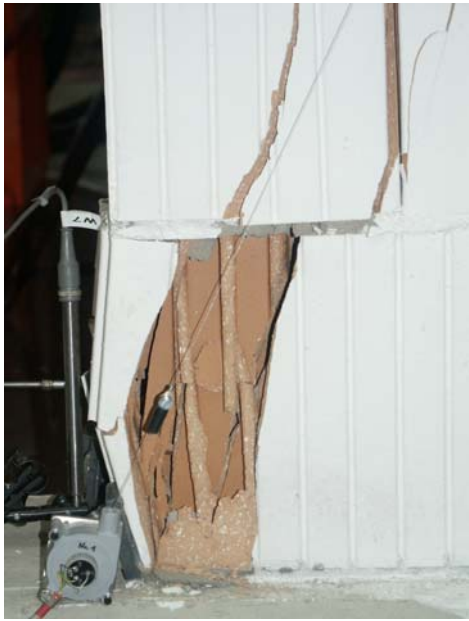
At a horizontal force of about -53 kN first cracking was audible. The first visible cracks appeared at a horizontal force of about -55 kN. The end of the test is determined by cracks in the bottom left corner of the wall, where shells of the vertically perforated bricks fell off (see figure A8-2).

figure A8-2: failure of test No. 8

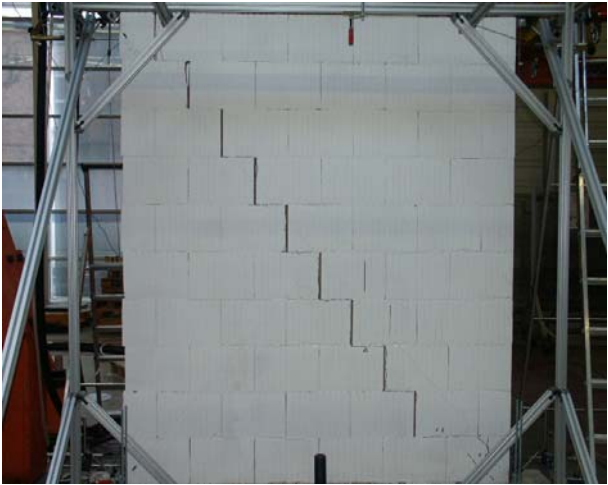
figure A9-2: crack pattern of test No. 9

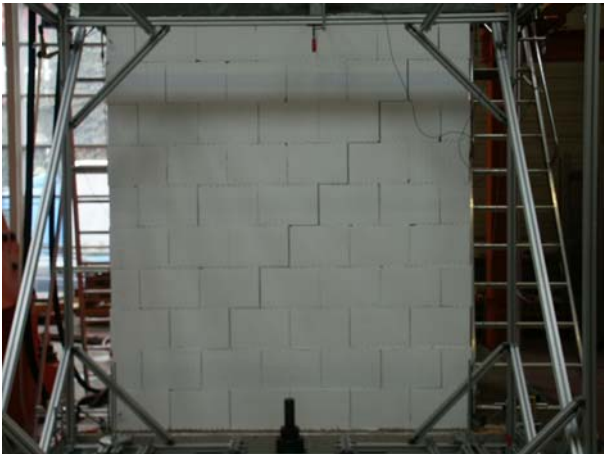
Already at a horizontal force of about -10 kN first cracking was audible. The first visible cracks appeared at a horizontal force of about +70 kN in the bed joints of the wall.

figure A15-1: first cracks at about 70 kN of test No. 15

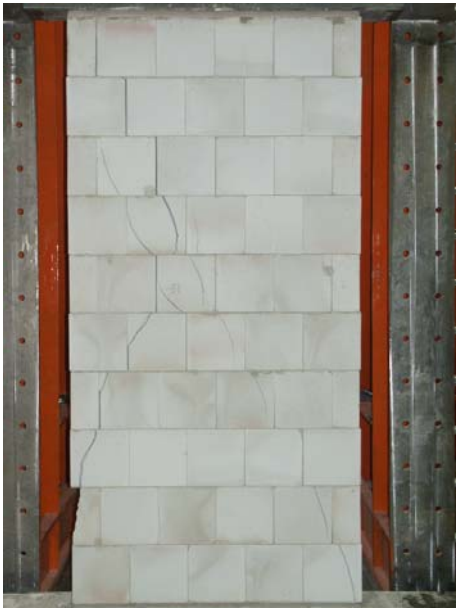
The first visible cracks in the units appeared at a horizontal force of about -81 kN (see figure A17-1). The end of the test is determined by a drop-out of a part of a unit in the bottom left corner of the wall (see figure A17-2).

figure A17-2: crack pattern of test No. 17

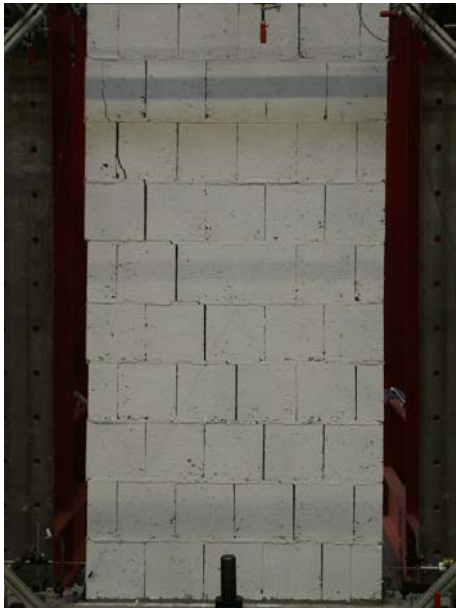
First visible cracks in the units appeared at the failure of the wall (see figure A18-1).

figure A18-1: crack pattern of test No. 18

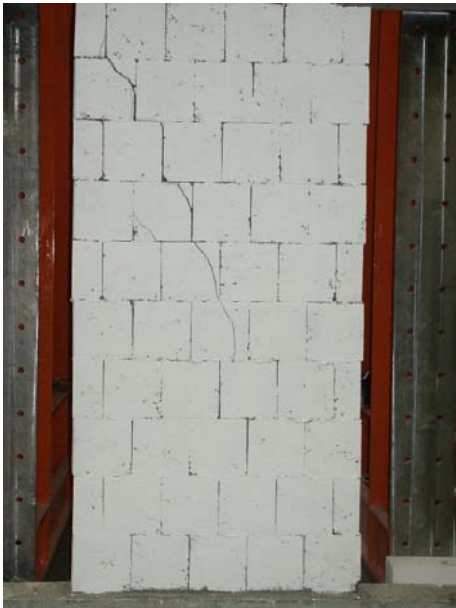
First visible cracks in the units appeared at the failure of the wall (see figure A19-1).

figure A19-1: crack pattern of test No. 19

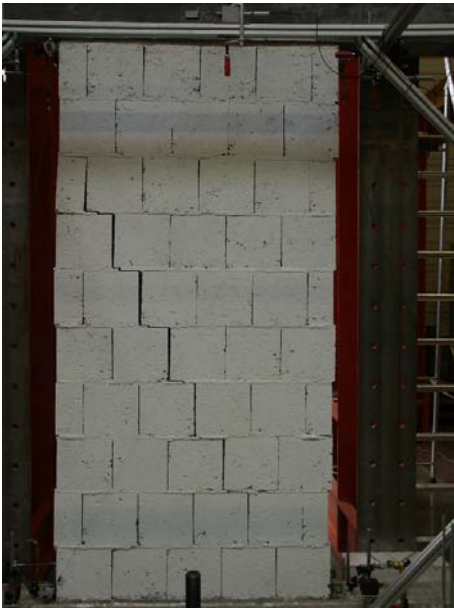
First visible cracks in the units appeared at the failure of the wall (see figure A20-1).

figure A20-1: crack pattern of test No. 20

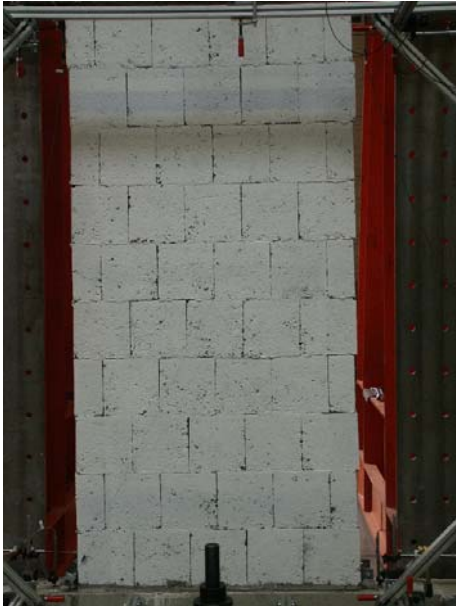
First visible cracks in the units appeared at the failure of the wall (see figure A21-1).

figure A21-1: crack pattern of test No. 21

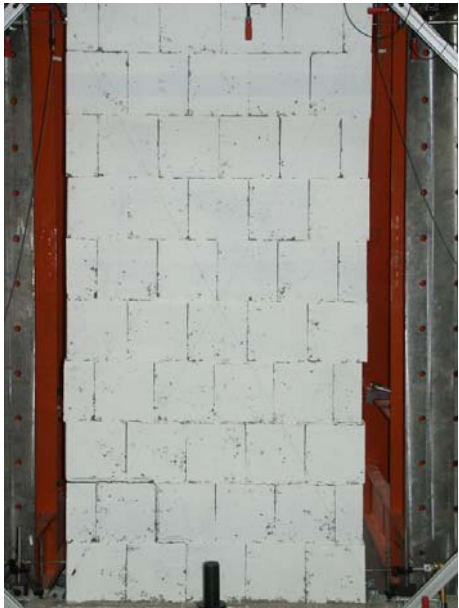
The first visible cracks in the units appeared at a horizontal force of about -48 kN (see figure A22-1). The end of the test is determined by cracks along the bed and the head joints (see figure A22-2).

figure A22-2: crack pattern of test No. 22

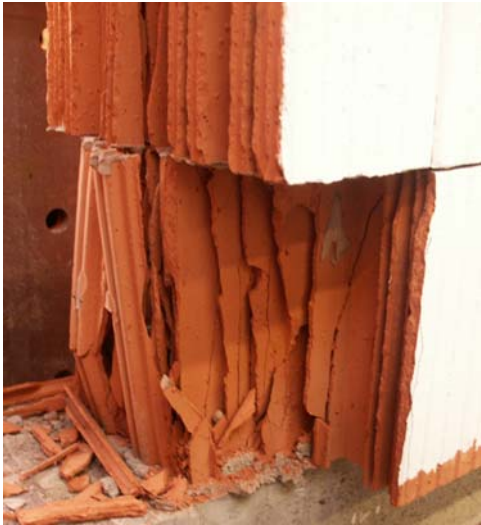
Already at a horizontal force of about ± 60 kN a first cracking is audible. The first visible cracks appeared at a horizontal force of about -100 kN in the first layer of the wall.

figure A23-1: first cracks at about ± 100 kN of test No. 23

figure A23-2: failure of test No. 23

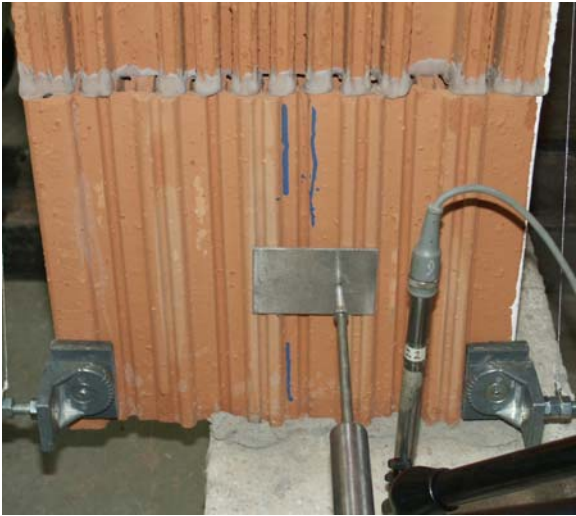
The first visible cracks appeared at a horizontal force of about -36 kN on the face side of head side of the first layer. With the increasing of the horizontal deformation diagonal cracks appeared at the loaded face side. The overlaying face side of the wall showed no cracks.

figure A25-1: first crack at the face side of test No. 25
